Originally published in: NuklearForum Schweiz, Materialprüfung mechanischer Komponenten in Kernkraftwerken, November 2009

2.1 E.ON REACTOR PRESSURE VESSEL NOZZLE INSPECTION ISSUE

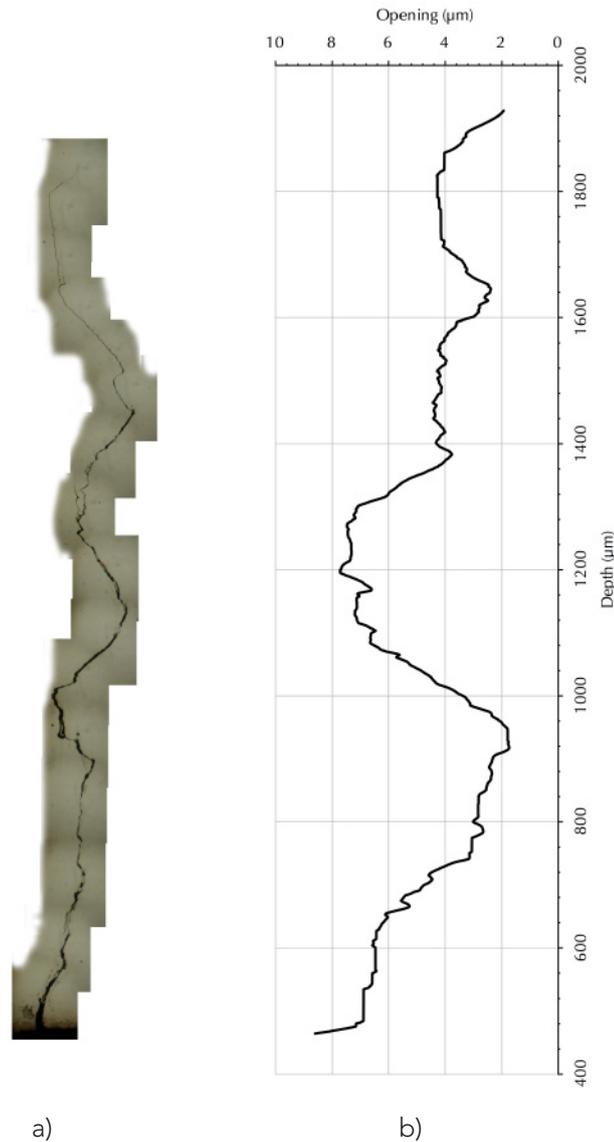
sectional sample was made to measure the crack opening profile in the depth direction. Next figure (Fig.3) shows a picture of the cross-sectional sample together with the opening profile measured.

Figure 1
Crack opening profile in depth direction together with the measured opening profile.
