## NOK CRDH

### 2.2 NOK CRDH INSPECTION ISSUE

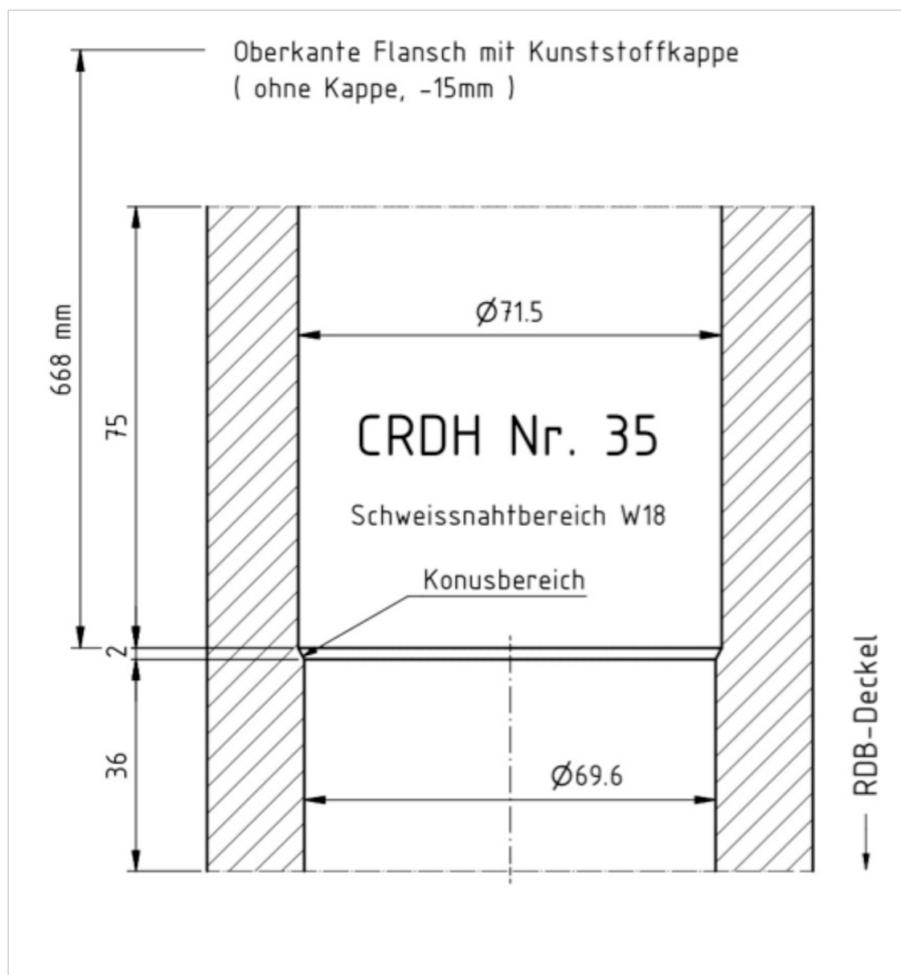
So, it was decided first to apply a qualified moulding technique on three penetrations to determine the ID contour. This investigation showed that there is an inner diameter difference between 1.5 and 2 mm and that the counterbores have different steepness. Next figure (Fig. 4) shows a drawing of the geometry based on the moulding result. Next step was to manufacture a sample representing the geometry of the real penetrations. Realistic flaws were needed to achieve reliable inspection results. The sample had to contain realistic cracks in different positions in the weld area. Furthermore, as the sample was already finished, the applied production technology had to deal with this.

**Figure 1**  
Example of a penetration ID contour.

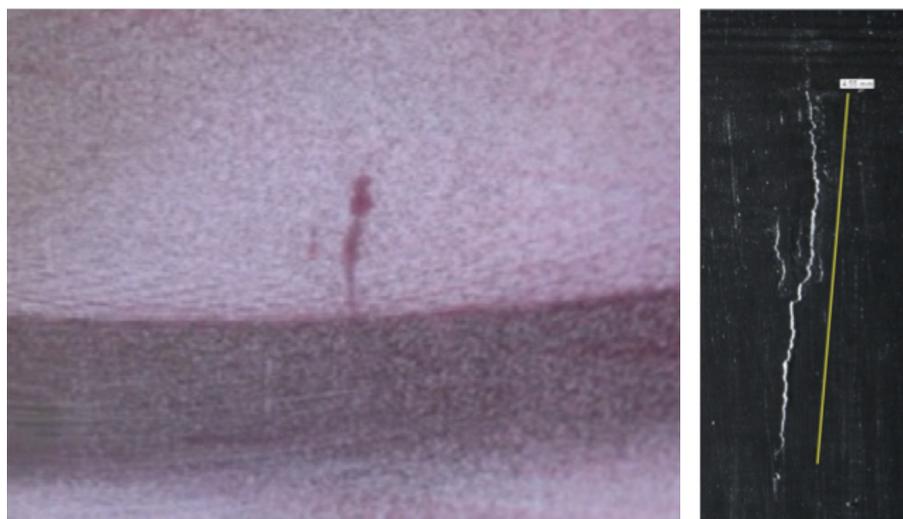
**Figure 2**  
PT indication with corresponding moulding indication (with secondary crack).

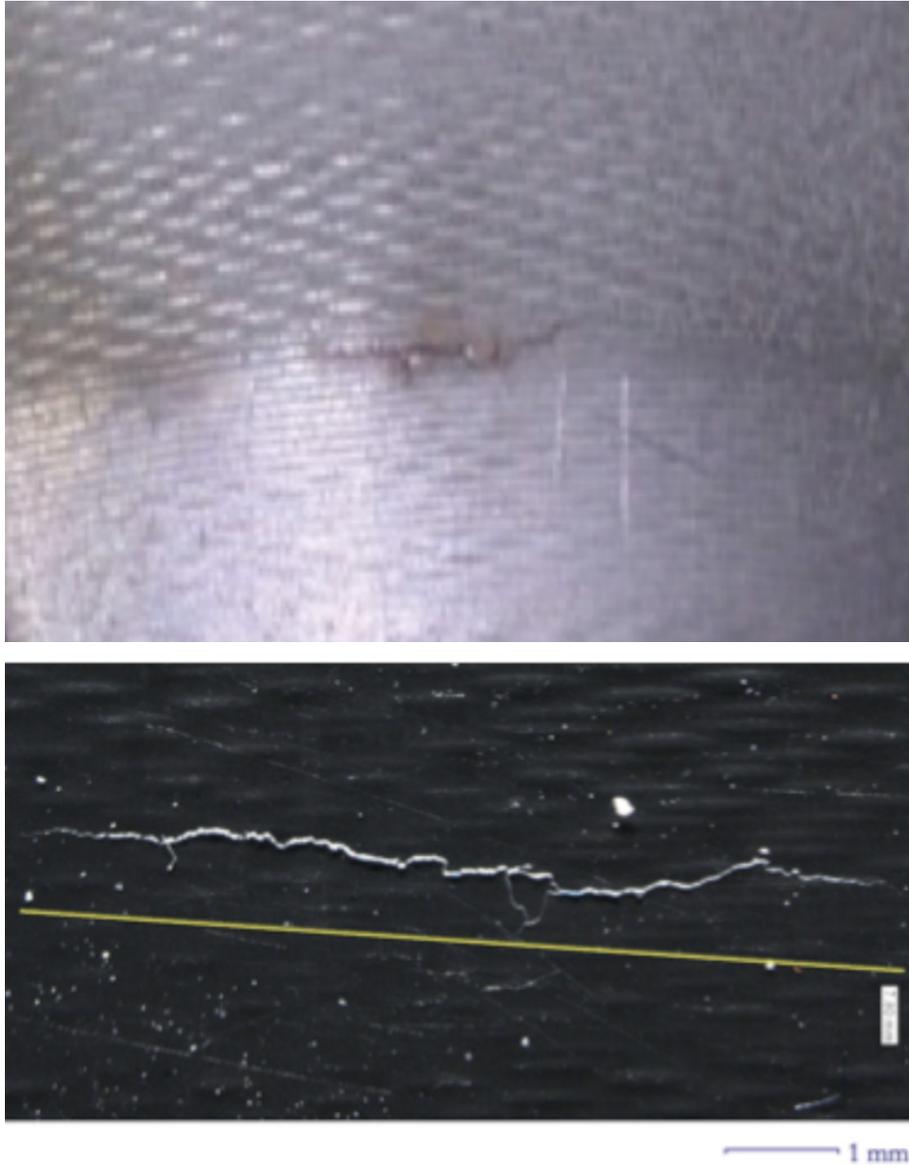
**Figure 3**  
PT indication with  
corresponding  
moulding  
indication.
