# CRACKED SAMPLES FOR AIRFRAME COMPONENTS

**Abstract.** Evaluation of NDT performance and reliability is an important part of any NDT system. Traditionally, the challenge has been limited supply of representative cracked samples, that would allow accurate evaluation of the achieved performance.

This paper describes production of cracked samples in airframe component representative of typical rivet hole configuration. The flaws were produced using local thermal fatigue loading and are representative of in-service fatigue cracks.

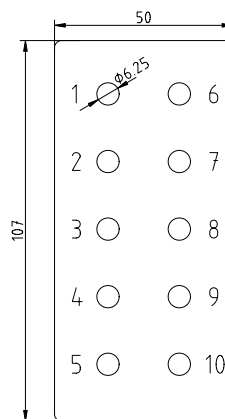
Figure 1. Sample geometry.

In present study, cracked evaluation samples representing a typical airframe component, i.e. a rivet hole was manufactured. Similar samples were manufactured in titanium and aluminum. Titanium is used both in the aero engines and in airframe and its thermal properties are closer to the previously cracked aero-engine materials. Thus, it was used as a reference material. Aluminum, on the other hand, is more interesting material for airframe components and more directly shows the potential for these cracks on the airframe components. Due to the different thermal conductivity and other material properties, the cracks produced in aluminum show somewhat different properties. The used sample geometries are shown in Figure 1.

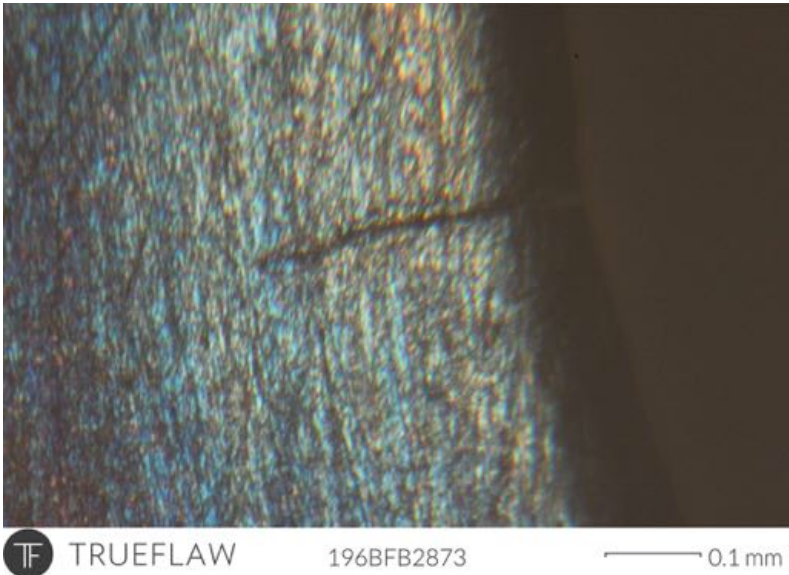
Figure 2. Microscopic image of typical crack in titanium.

Table 1 shows the generated cracked samples and associated crack sizes. Figures 2 and 3 show typical microscopic images of generated cracks in titanium and aluminum, respectively.

The microscopic characterization shows that cracks initiate from the hole surface and grow following the local microstructure as expected for natural fatigue cracks. The cracks initiate at the hole corner and extend to both directions. The cracks in titanium show, in general, smaller crack opening than those in aluminum. This can be caused by both different material properties and different loading conditions. The smaller yield strength of the aluminum increases crack tip plastic zone size and increases crack tip blunting and crack opening for similar stresses. In the future, this could be alleviated to some extent by decreasing the loading (with corresponding increase in the crack production time). The aluminum samples also showed some increased oxidation during the loading. This can be attributed to both the increased temperature and the interaction between the deformation and oxidation (i.e. the oxide film may break during tensile loading and expose new material to the environment). The oxidation also caused conductivity changes, which caused phase angle change in eddy current inspection. This tendency was reduced using corrosion inhibitors in the cooling medium. Nevertheless, mechanical removal of affected oxide layer was necessary after production. Although these issues were reduced by the use of inhibitor, some additional development is necessary to fully remove oxidation effects.

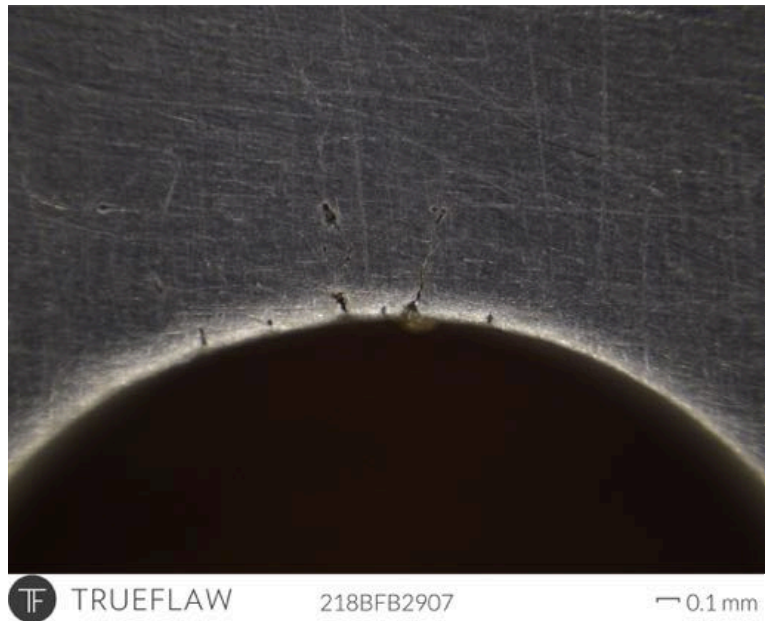
Figure 3. Microscopic image of typical crack in aluminum.

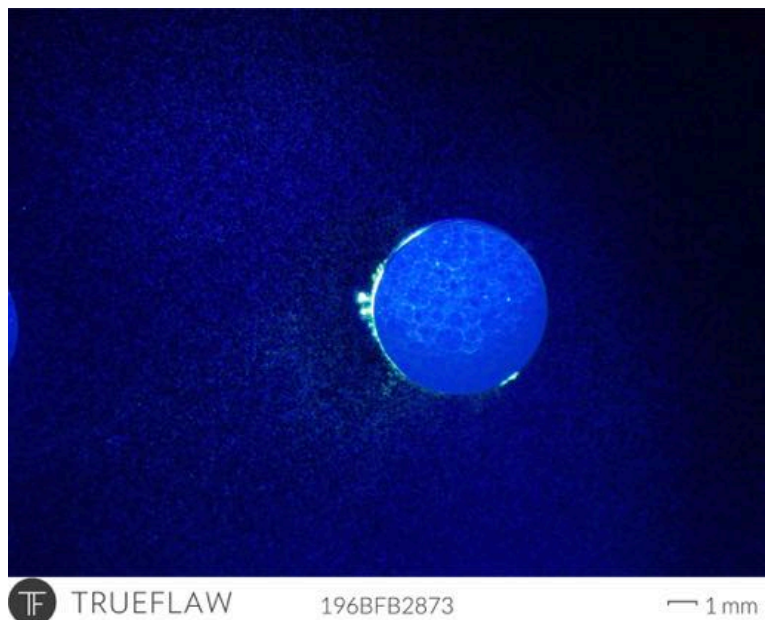
Figure 4. FPI image of typical crack in titanium. The crack is the same as that depicted in Figure 2 (Trueflaw crack number 196BFB2873).

The manufactured cracks were first inspected using fluorescent dye penetrant (FPI) at Trueflaw. The samples were subsequently sent to Patria for representative eddy current inspection and further evaluation. At Patria, inspection more closely representing the actual inspection for airframe components were conducted. Figures 4 and 5 show typical FPI-images for titanium and aluminum samples, respectively. Figures 6 and 7 show corresponding EC-images.

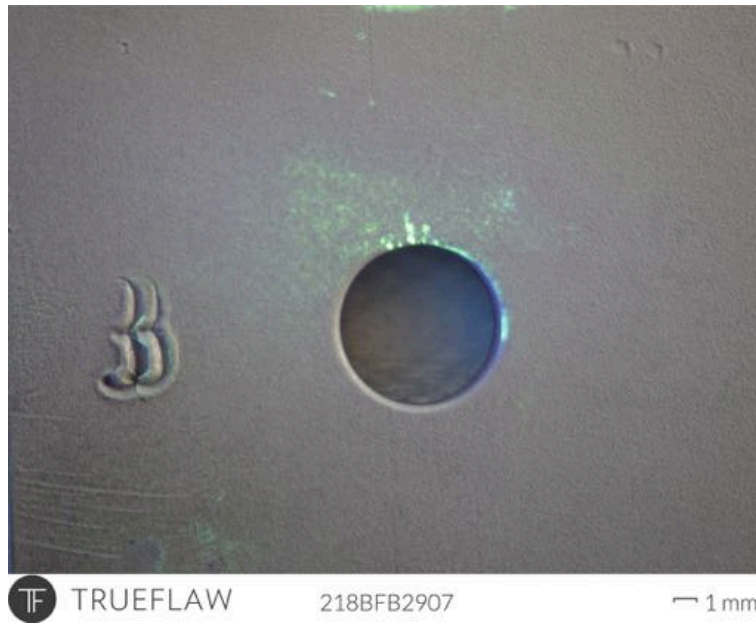
Figure 5. FPI image of typical crack in aluminum. The crack is the same as that depicted in Figure 3 (Trueflaw crack number 218BFB2907).

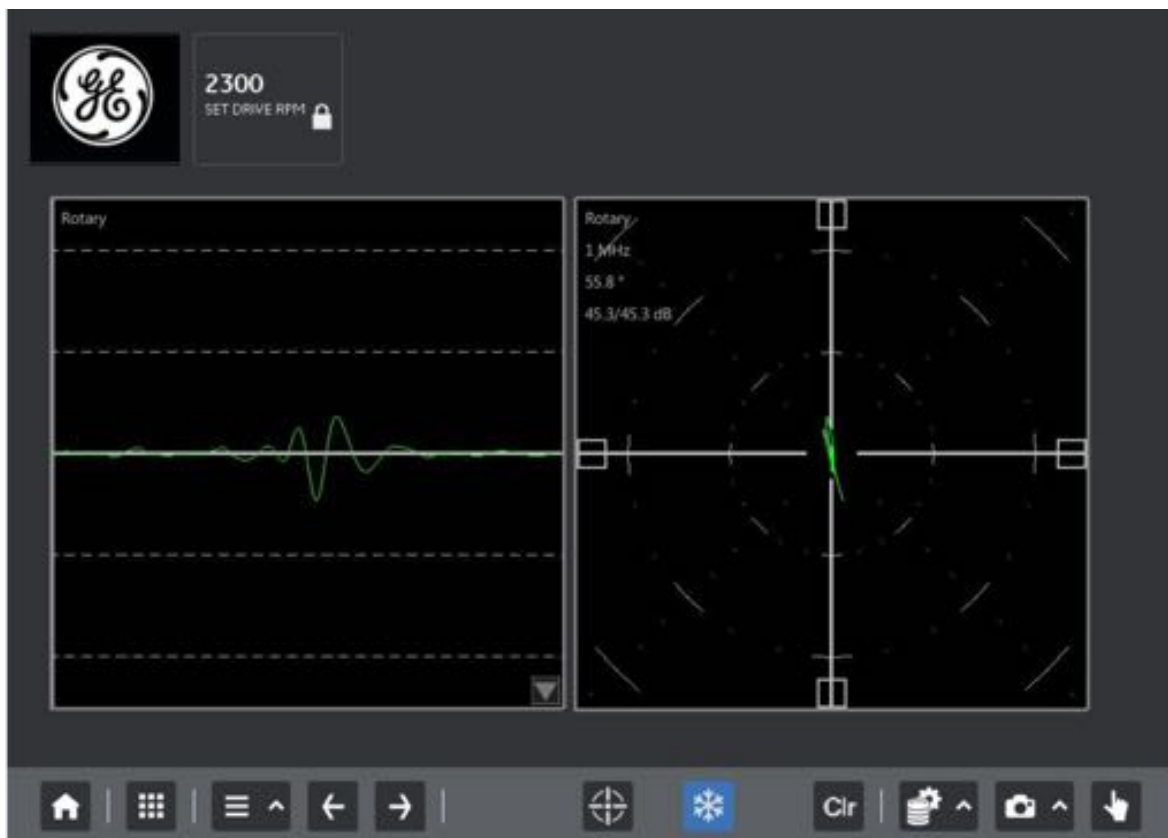
Figure 6. EC image of typical crack in titanium. The crack is the same as that depicted in Figures 2 and 4 (Trueflaw crack number 196BFB2873).

The eddy current inspection showed detectable indications for all but the smallest cracks. The signals were comparable to those expected of a service-induced cracks in titanium. In some of the aluminum cracks, the eddy current signals differed slightly in phase angle and in form from service-induced cracks. The cracks were still detectable, as shown in Table 2. Consequently, the cracks were evaluated positively for further use in airframe NDE performance demonstration use. The current sample set was too small for proper POD analysis. Nevertheless, the results already give better indication on the capabilities of the NDE techniques used and can be used to focus further effort on POD determination to interesting range of crack sizes.

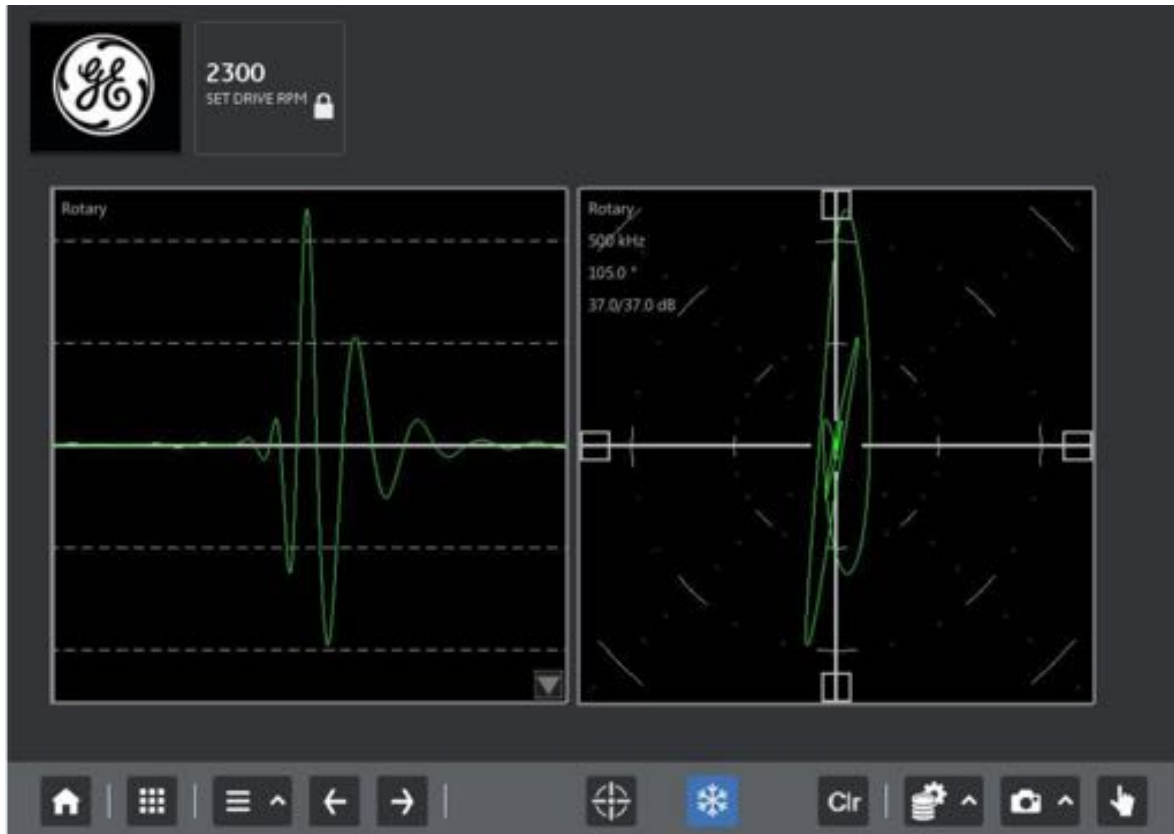
Figure 7. EC image of typical crack in aluminum. The crack is the same as that depicted in Figure 3 (Trueflow crack number 218BFB2907).

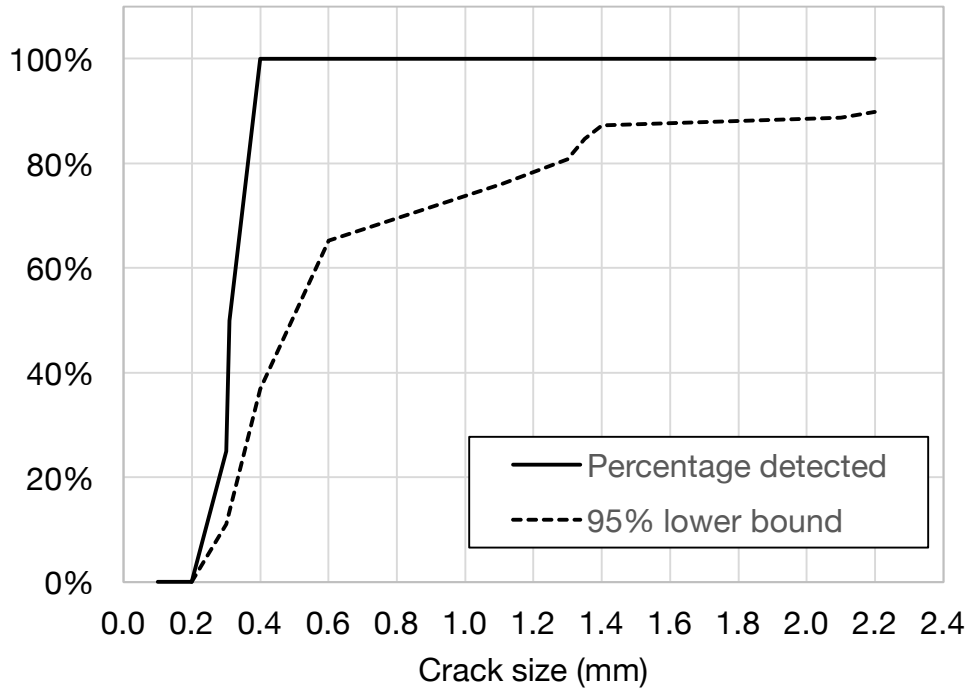
Figure 8. Summary of inspection results. The solid line shows the detection as percentage from trials in Table 2. The dashed line shows rough estimate 95% confidence bound based on the binomial model (true POD above this line would show the better-than-given results at 95% confidence, assuming POD increases with increasing crack size). The data is insufficient for true POD analysis and thus this is likely to seriously underestimate the true POD.

The inspection results on various used EC techniques is collected in Table 2 and depicted graphically in Figure 8. The number of cracks generated for this preliminary study is insufficient for full ASTM-E2862 POD analysis. However, the results demonstrate, that an array of cracks ranging from undetectable to clearly detectable can now be produced in materials and components representative of typical airframe components.
