# **ADVANCES IN PRODUCTION OF REALISTIC CRACKS TO NDT DEVELOPMENT AND QUALIFICATION PURPOSES OF STEAM GENERATOR TUBES**

**I. Virkkunen<sup>1</sup>, M. Kemppainen<sup>1</sup>, J. M. Tchilian<sup>2</sup> and J. Martens<sup>3</sup>**

## **Abstract**

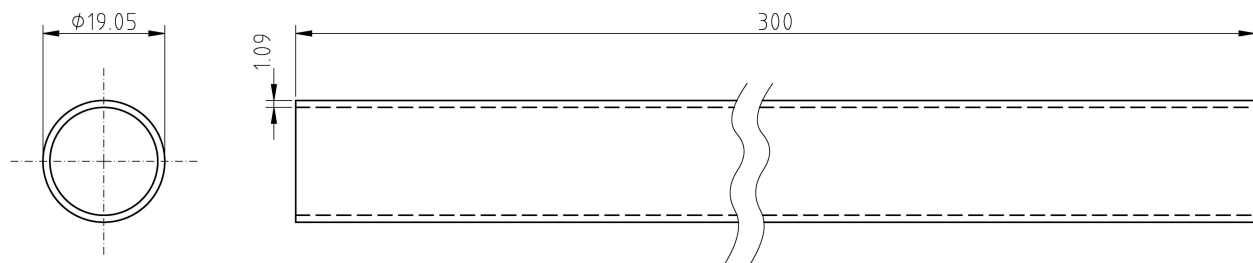
Figure 1 Tube sample drawing. The material is Inconel 690.

The qualification done for OL-3 was the first to be completed on Inconel 690 tubes with real cracks. Consequently, no cracked specimens were available nor had such specimens ever had been manufactured. Areva NP approached Trueflow to manufacture the cracked samples. Figure 1. shows drawing of the tube sample used in qualification.

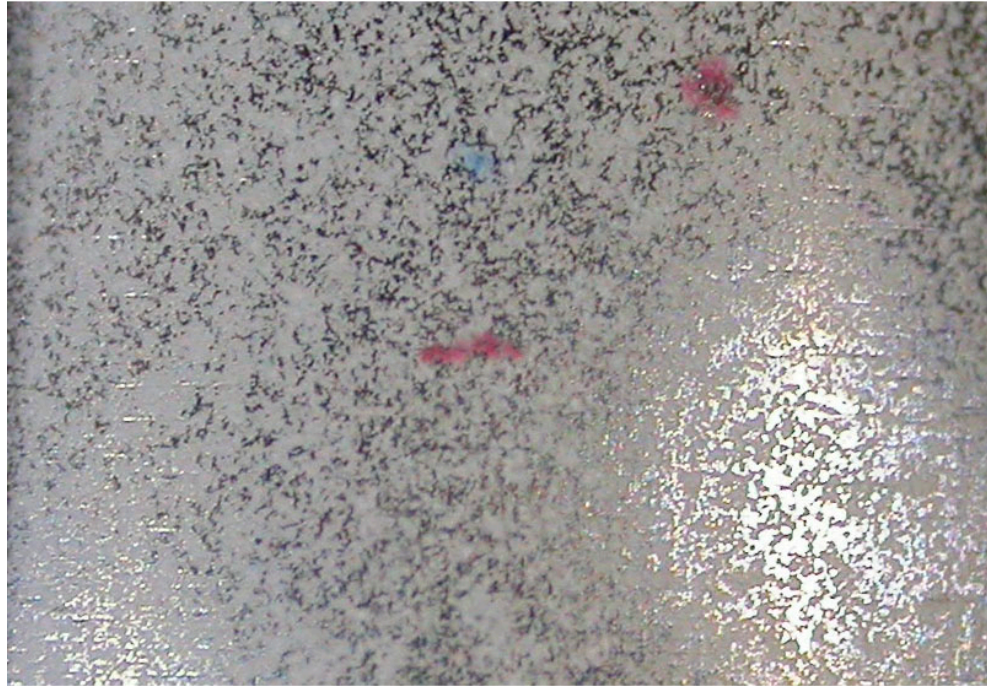
218AHB594

Figure 2 Small crack initiation in Alloy 690 steam generator tube; a dye penetrant indication.

Hence, the first target was to obtain successful small crack initiation to this new material with the thin wall section. After several trials, successful circumferential cracking was obtained (Figure 2). However, rather unexpected difficulties were met when developing technique for axial cracking. As it turned out, the material was highly anisotropic with respect to cracking. Presumably this is caused by the microstructural texture resulting from tube manufacturing. It was noticed, that the samples strongly preferred circumferential cracking over axial cracking. Consequently, no axial cracking could be produced without accompanying circumferential cracking.

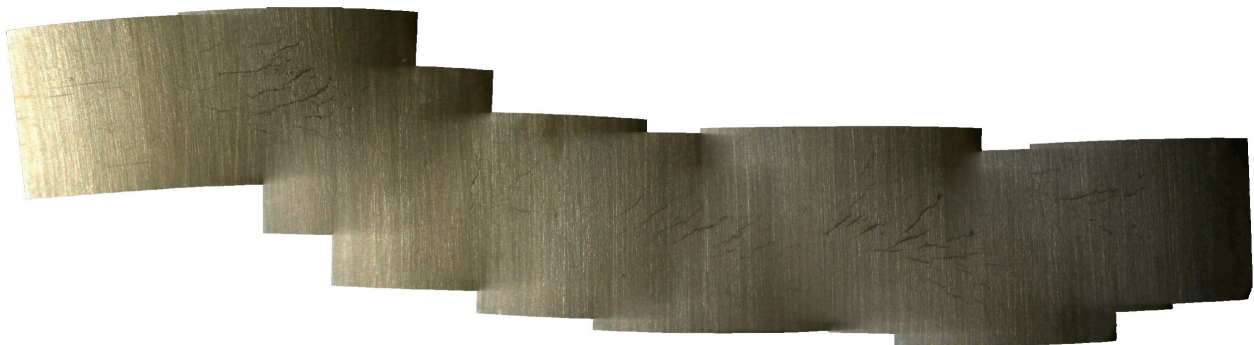
311AHB665

Figure 3 Circumferential cracking in steam generator tube samples.

The specified cracking included long and shallow cracks, i.e. the cracking extended up to several millimeters around the circumference but only a fraction of a millimeter in depth direction. Consequently, the production was met with a problem of through wall cracking. That is, successful crack initiation was obtained, but as soon as the surface length of the crack was extended, cracks rapidly grew through-wall. To overcome this problem, it was decided to produce the desired dimensions with non-contiguous cracking. Figure 3 shows such a non-contiguous crack pattern produced.

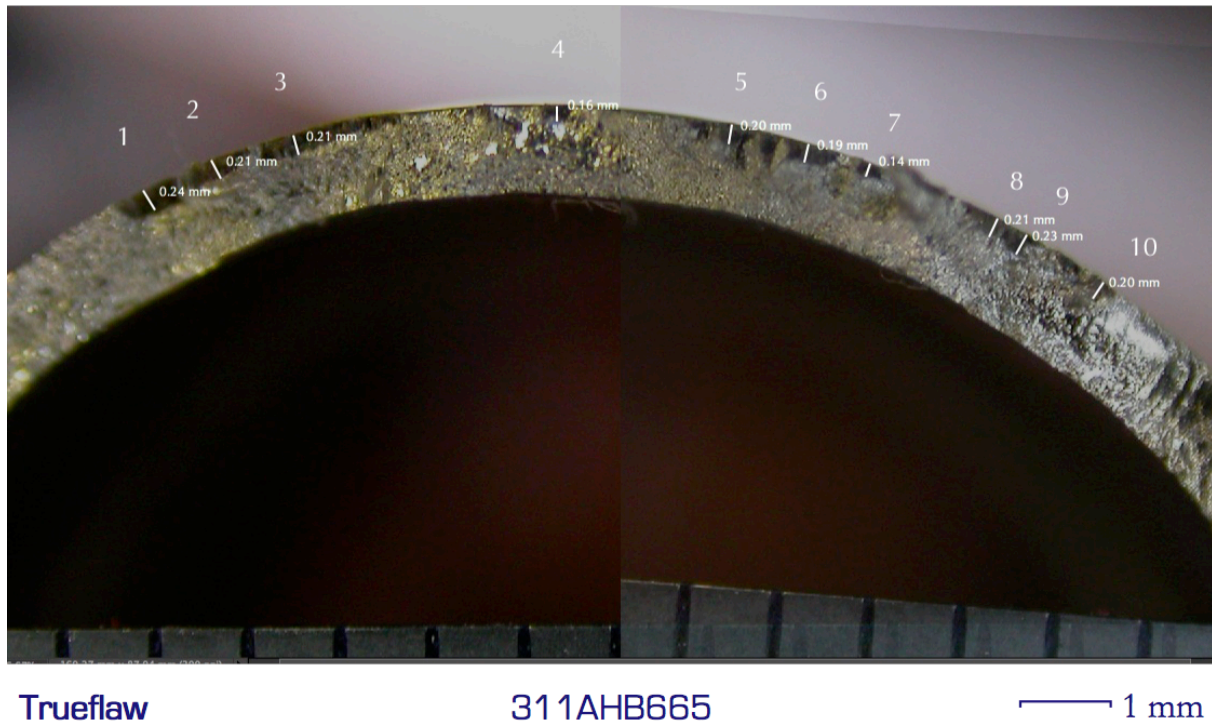
Figure 4 Destructive examination of produced validation cracks in the SG tube sample.

validation samples were destructively examined by Trueflaw in order to confirm the depth of the cracks. Figure 4. shows an image of destructive examination of a validation sample.

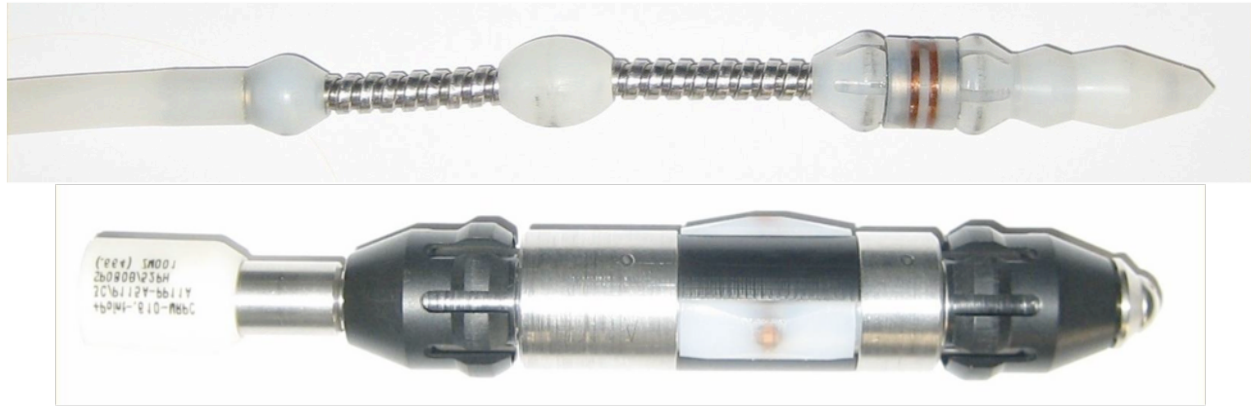
Figure 5 The probes used in the inspection were ET Bobbin probe, Zetec 610UL (upper image) and ET rotating probe, Zetec 3 coil 610PP with 1 +point coil PP11A, 1 pancake coil 115MR Ø 3 mm (medium range) and 1 pancake coil 080 HF Ø 2 mm (High frequency) (lower image).

Three samples were inspected with eddy current inspection by Intercontrole. The samples are detailed in Table 1. Inspection was carried out with two different probes: bobbin probe and rotating probe (Figure 5).

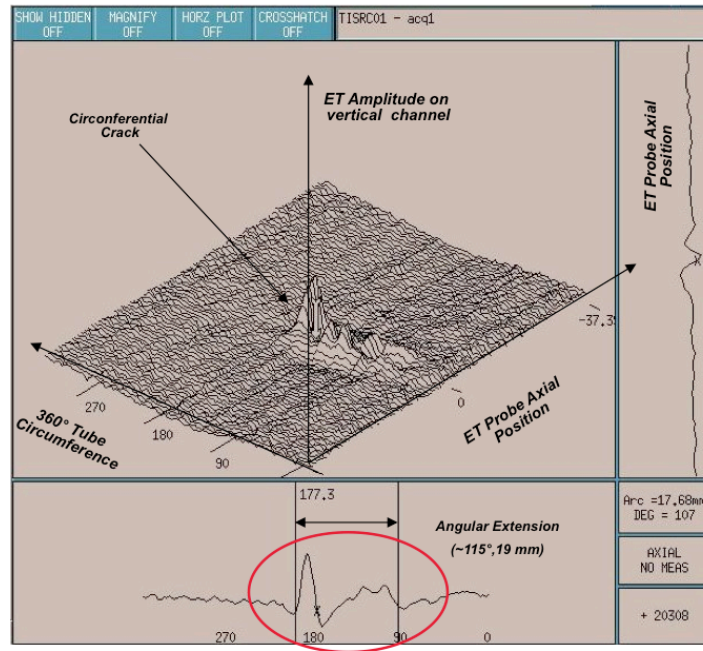
360° Tube Circumference  
Figure 8 ET probe results for sample 1 for the rotating probe.

The EC response of cracks in each sample with two different probes can be seen in Figures 6-14. Three different pictures are shown for each sample: first the result of bobbin probe then results of rotating probe signals and finally topographic picture of the rotating probe response. The crack signal is marked to each image. The ET bobbin probe clearly detects single indication for all the inspected samples. For samples 1 and 2 the indication is correctly interpreted as OD defect and for sample 3 the indication is correctly interpreted as through-wall defect.

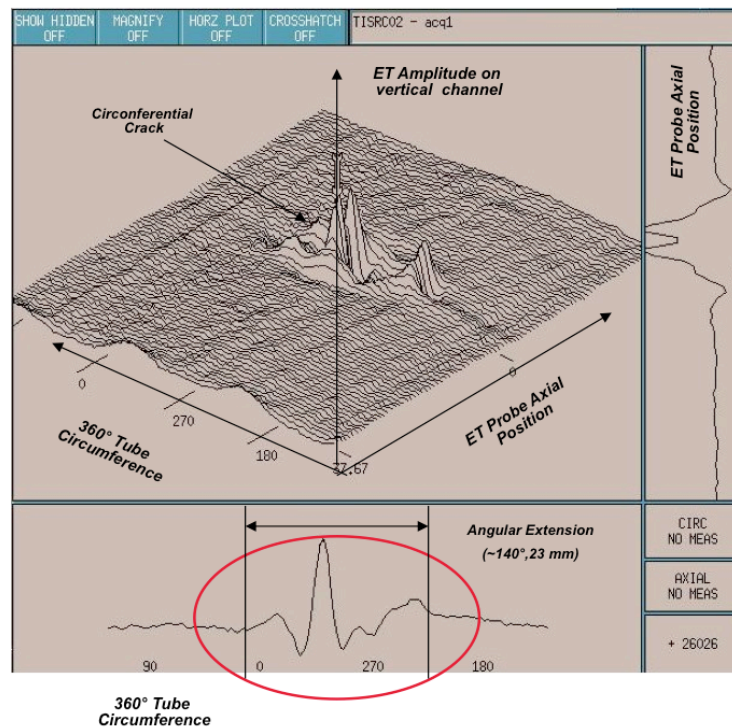
Figure 11 ET probe results for sample 2 for the rotating probe.

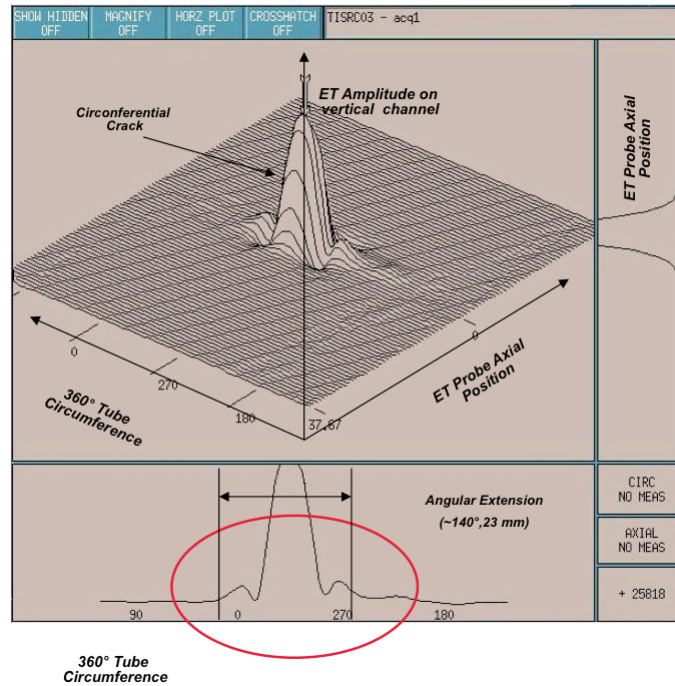
Figure 14 ET probe results for sample 3 for the rotating probe.

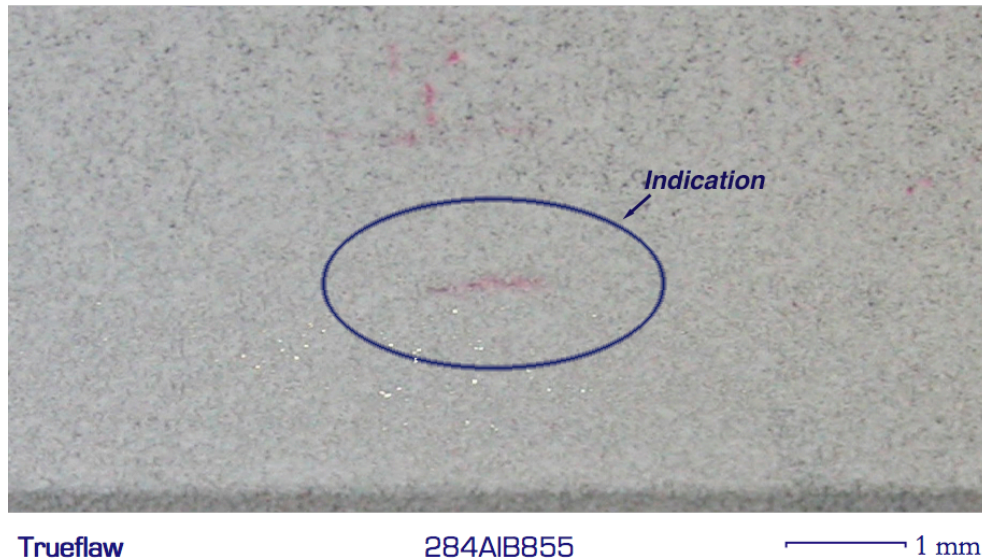
Figure 15 Typical initiation images for axial cracks in austenitic stainless steel steam generator tubes.

Trueflow completed altogether nine production tests for this tube. With these tests, it was shown that axial cracking can be repeatably initiated to austenitic stainless steel tubes and size controlled to produce axial cracks with known size. During the limited testing, however, the method was not conclusively validated. The follow-up for this work is currently considered. Typical initiation images are shown in Figure 15. Produced cracks are very tight and thus PT image show very poor contrast. Corresponding images from destructive examination are shown

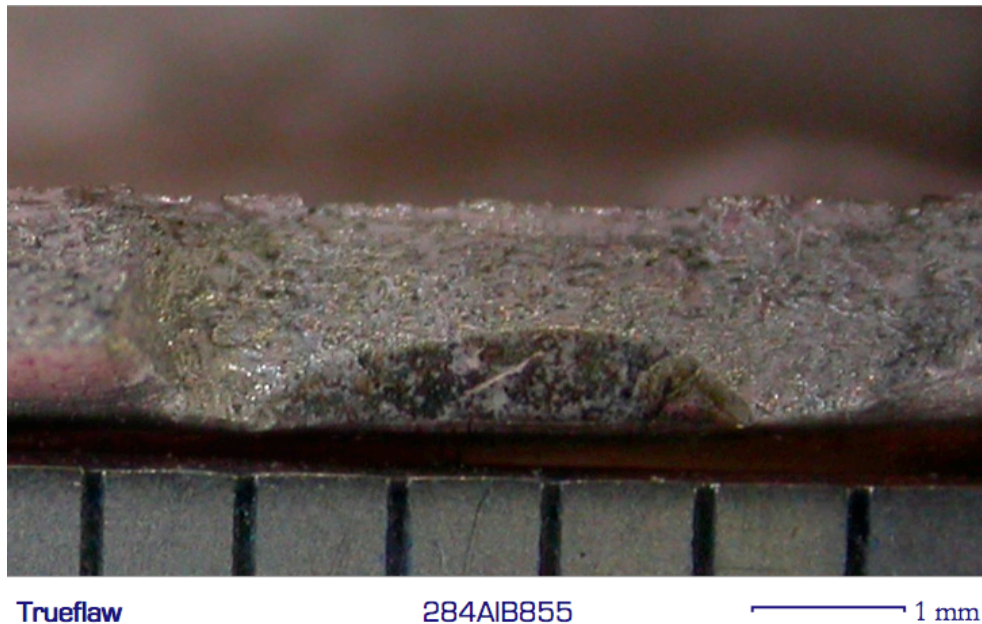
Figure 16 Destructive examination results for axial cracks in austenitic stainless steel steam generator tubes.

in Figure 16. It can be seen, that the crack is continuous and follows the long-but-shallow aspect ratio specified for these cracks.
