# NEW FLAWS FOR QUALIFICATION OF CAST STAINLESS STEEL INSPECTION

Iikka Virkkunen, Trueflaw Ltd., Finland,  
Doug Kull, EPRI NDE-Center, USA,  
Mika Kemppainen, Trueflaw Ltd., Finland

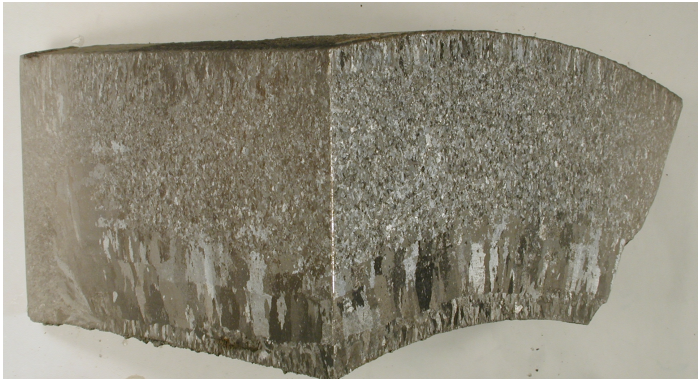
Figure 1. Example of the samples grain structure

To develop test blocks for cast austenitic stainless steels, three samples were provided by EPRI. The samples were centrifugally cast CF-8M grade stainless steel with a varied equiaxed grain structure. Figure 1 shows a section of the material, used for this study, which has been polished and etched to show the grain structure. Two of the samples were used for
