# **NEEDS FOR MASSIVE MOCK UPS AND CHALLENGES IN MANUFACTURING OF THEM FOR QUALIFICATION PURPOSES**

Author: Jani Pirinen, Fortum Power and Heat Oy  
Co-authors: Raimo Paussu, Veijo Nikula, Fortum Power and Heat Oy,  
Iikka Virkkunen, Mika Kemppainen, Kaisa Miettinen Trueflaw Ltd.

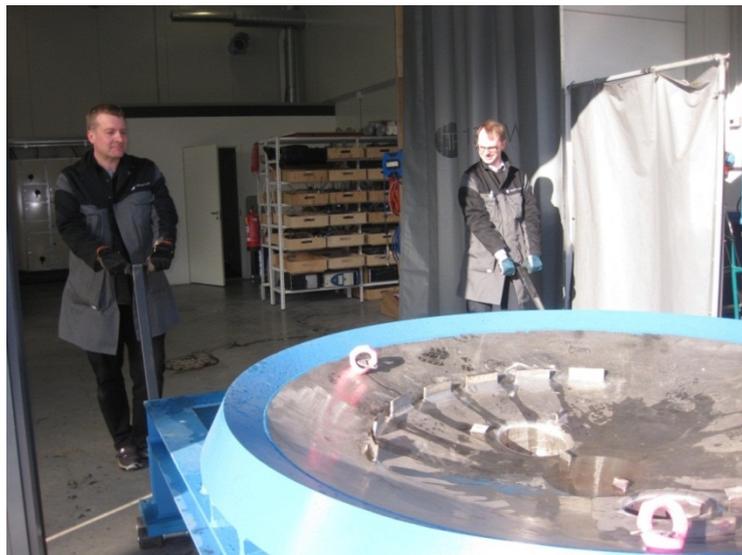
**Figure 6.** The Massive mock-up rolled into Trueflaw facilities.

For Trueflaw, the pressurizer bottom was the largest mock-up to date. This caused some need for special arrangements. In particular, moving the heavy mock-up from transportation vehicle into suitable location at the shop floor and back to transportation vehicle required special attention (see Figure 6). The production location and transportation was well planned ahead and went accordingly. For flaw production, the mock-up size caused some additional challenges. The mock-up could not be rotated to optimal location for accessibility. Thus, the designated flaw locations were out of reach for normal flaw production tools. Special tooling with extended arm length was developed for this application. The extended arm also resulted in increased tool flexibility, which necessitated some additional fixtures to allow reliable flaw production. Although the need for further tooling was foreseen, it was also recognized that the specific needs may change due to changes in flaw location or sample orientation. Thus, the tooling was completed when the sample was already in place and tools could be adapted to the exact requirements of the situation. Overall, combination of good preparation and adaptability made producing cracks to massive mock-up successful without major extra effort.

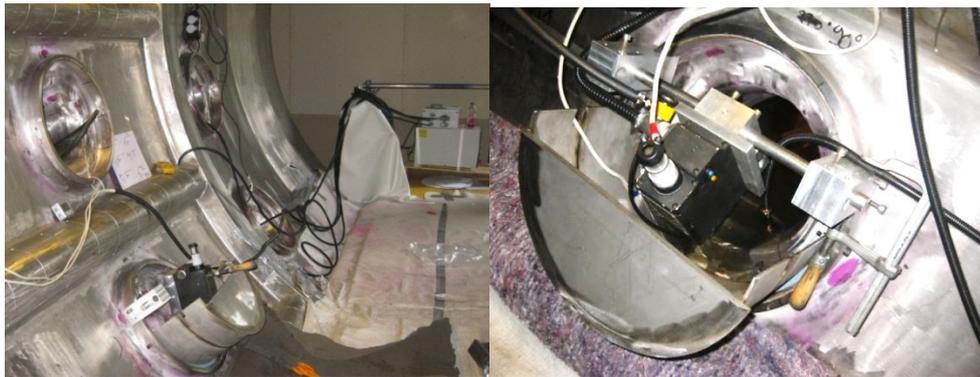
**Figure 8.** General view from the assembly of the manufacturing system on left and assembly of the EDM machining head on the right

Manufacturing activities continued again on the summer 2013 with solidification cracks. After that all EDM notches have been manufactured. Changes in material properties caused an unexpected challenges during the openings for welded flaws. Due to the hardness differences from expected the used manufacturing tools were needed to be changed. Local heating was also needed to avoid moisture based hydrogen problems. Similar challenges in assembly of the EDM machining occurred as during the machining of the pressurizer bottom head. Also expected normal machining challenges at the beginning of the machining had to be solved. After optimal parameters were reached the position of the EDM head has been the most challenging task to do. In this case the modification needs could not be excluded to predesigning. General view from the assembly of the EDM manufacturing system and assembly of the EDM machining head are presented in the Figure 8. Parts of the system is located to outside of the reactor pressure vessel, the air filter of the local ventilation and fluid collector (see the Figure 9). There can be seen the plugged nozzle which is also used as the pool for fluid.

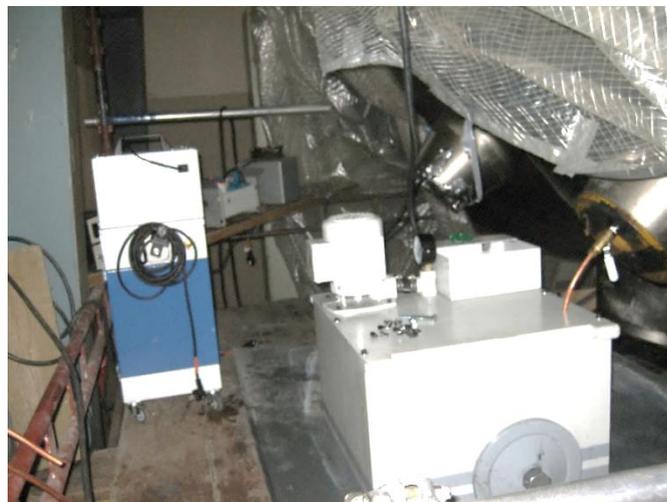
**Figure 9.** General view from the assembly of the manufacturing system outside of the reactor pressure vessel. In the front right is fluid collector and on the left side behind is the air filter of the local ventilation
