# FORTUM STEAM COLLECTOR

*Originally published in: Insight Vol 51 No 5 May 2009*

## 3.2 FORTUM STEAM COLLECTOR PRIMARY COLLECTOR

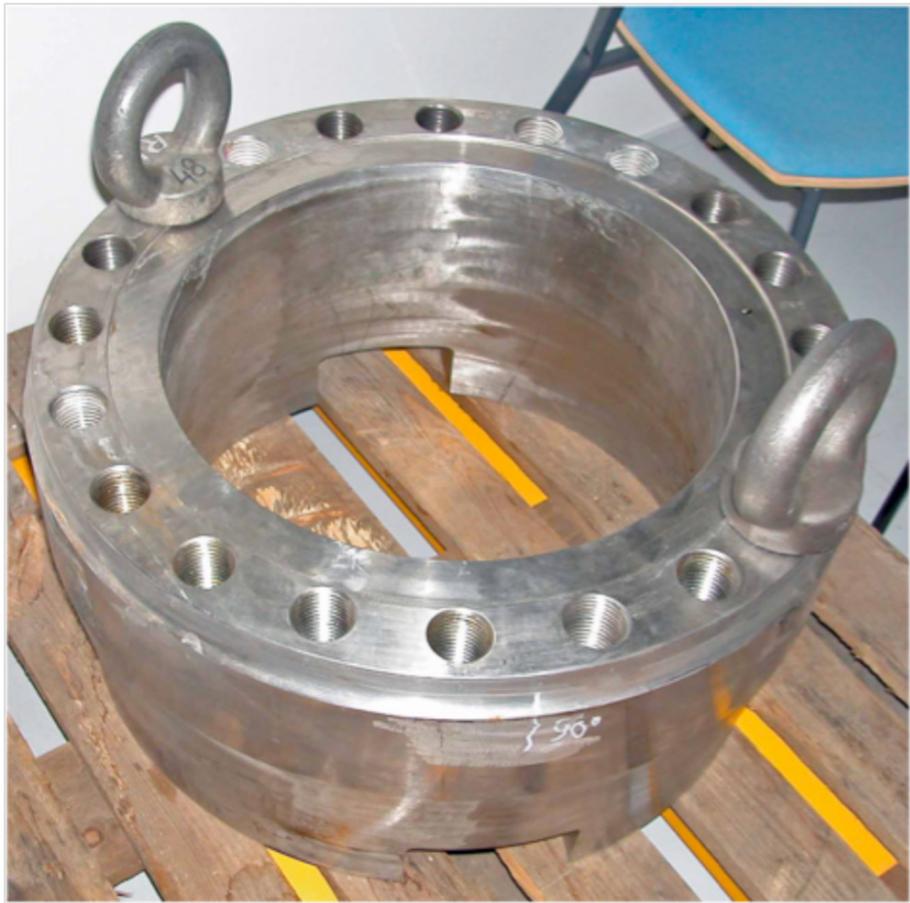
Figure 2  
Loviisa test block  
from vintage  
material.

The area of interest is cracking in M48x5 threaded holes of the primary collector flange. The inspection is done using phased array UT with scanning from top and inner diameter (ID) surface of primary collector. It was decided to use component removed from a similar powerplant, that never went to operation as a test block for the qualification. Figure 4. shows the qualification test block. The flaw types to be detected are shown in Figure 5.

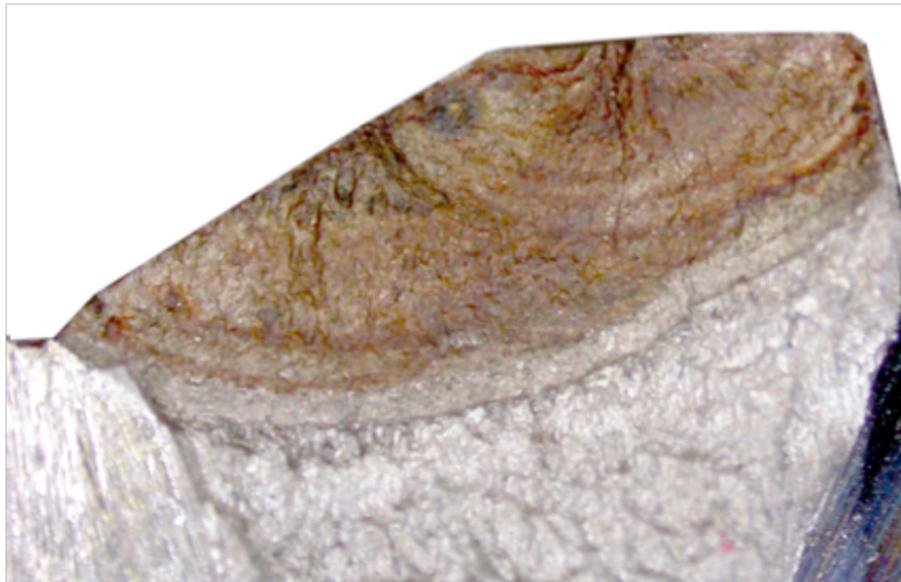
**Figure 4.** Fracture surface from a destructively examined validation crack corresponding to crack type 3 in Figure 3.

Trueflaw produced validation cracks for all the desired flaw sizes and locations and supplied destructive evaluation report to Fortum. After accepted validation, the production of the actual qualification defects were done and test block supplied to Fortum. Figure 6 shows an example of a fracture surface from this validation. Thermal fatigue cracks were supplemented with a selection of EDM-notches in different locations.
